FONAR Upright™ Full-Range-of-Motion Multi-Position™ MRI Uncovers “Hidden Disc”

More Proof: Case Study #5

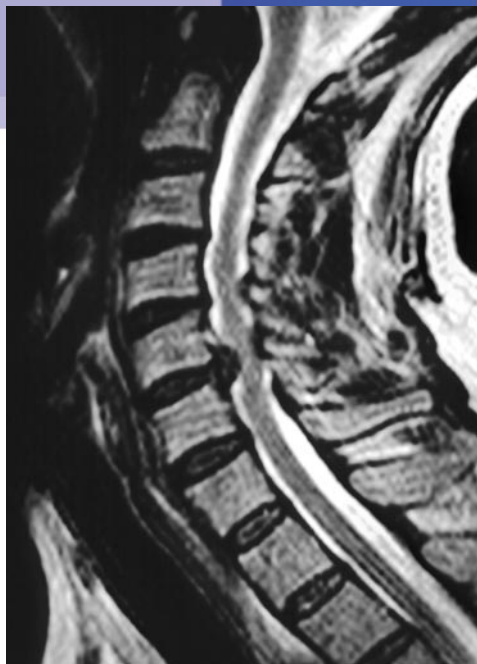
Upright Neutral

A 62-year-old woman with chronic neck pain of 30 years duration that radiated into the patient's shoulders, sought upright weight-bearing flexion-extension MRI to visualize the origin of her pain. Her neutral-sitting examination showed a C5-6 herniation, but upon extension an additional herniation appeared at C4-5.

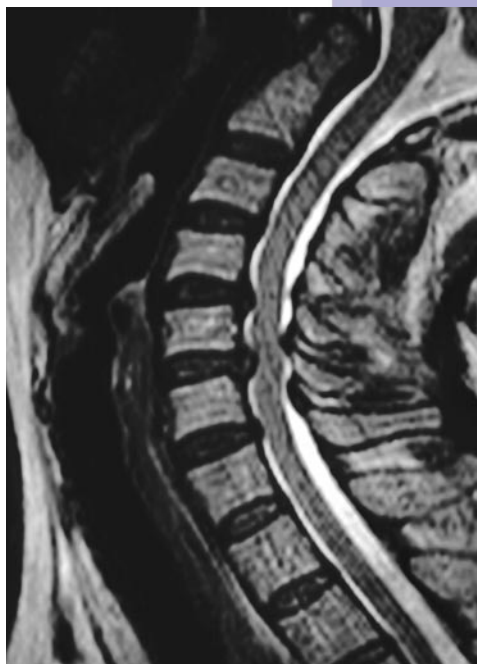
Upright Extension
