**FONAR WALK-IN™
FULL-RANGE-OF-MOTION™
MULTI-POSITION™
UPRIGHT™ MRI
Uncovers
“Hidden”
Disc Herniation and
Spinal Instability**

More Proof: Case Study #6

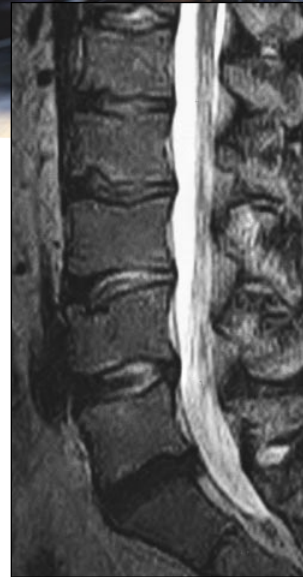
Recumbent

The recumbent image showed degenerative disc disease at L5/S1 and a minor disc bulge at this level.

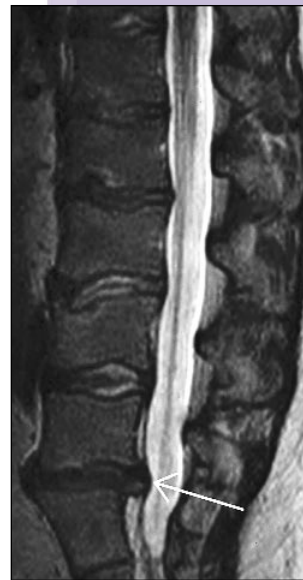
Upright

The upright image revealed a focal posterior disc herniation (arrow) at L5/S1 and further narrowing of the disc space. In addition, an intersegmental hypermobile instability (retrolisthesis) was present at the same level when the patient was upright.
